EXHIBIT E

DAVID H. SMITH & ASSOCIATES

September 25, 2005

RE:	Loss Location:	County Road 79, Apt. 1 Daviston, AL
	Date of Loss:	April 13, 2005
	Client Claim No.:	P5-119-J
	Our File No.:	12-3163.17

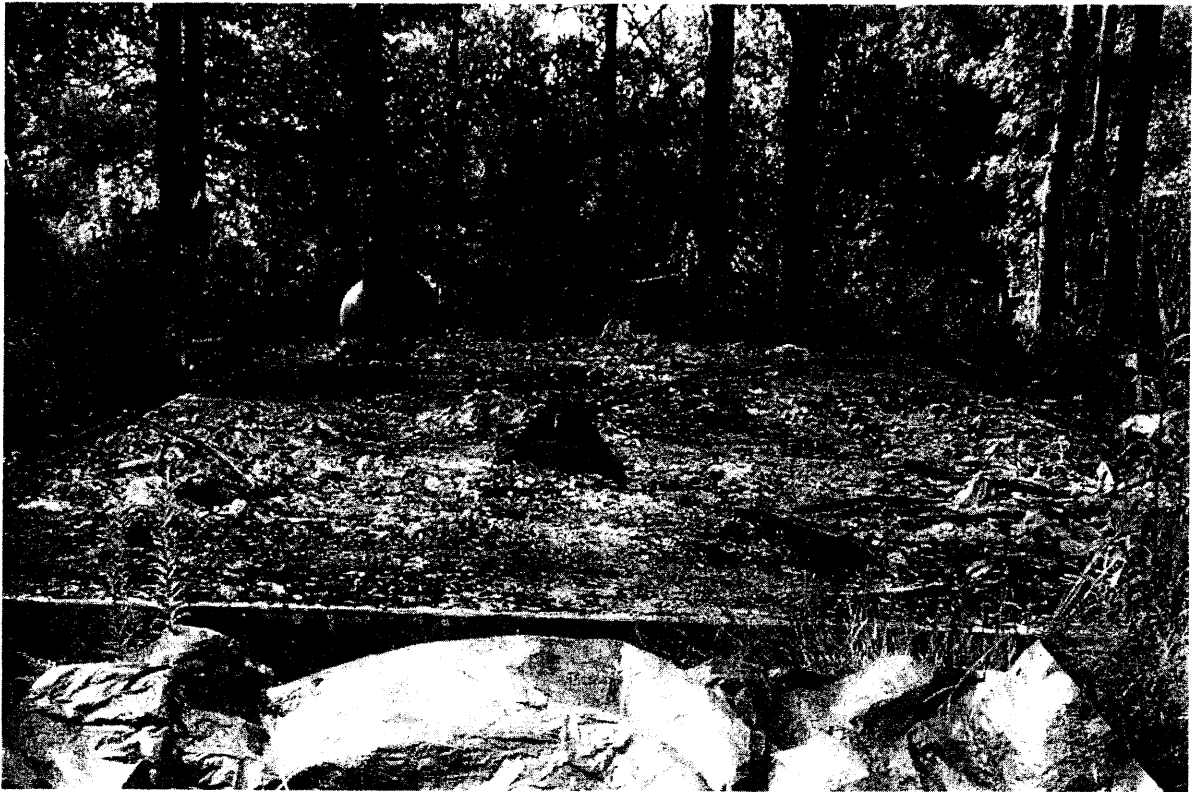
Figure 1 – Fire Loss site prior to excavation and sifting process.

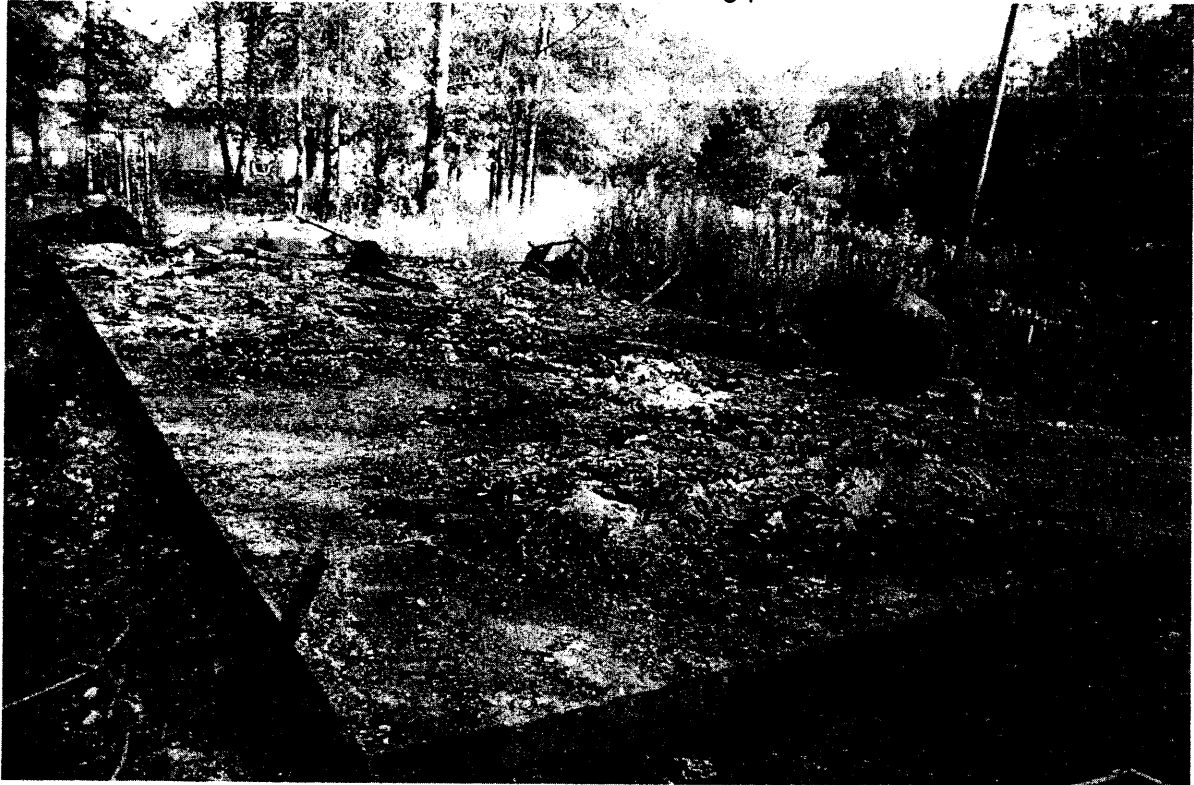
Figure 2 – Fire loss site as viewed during the excavation process.

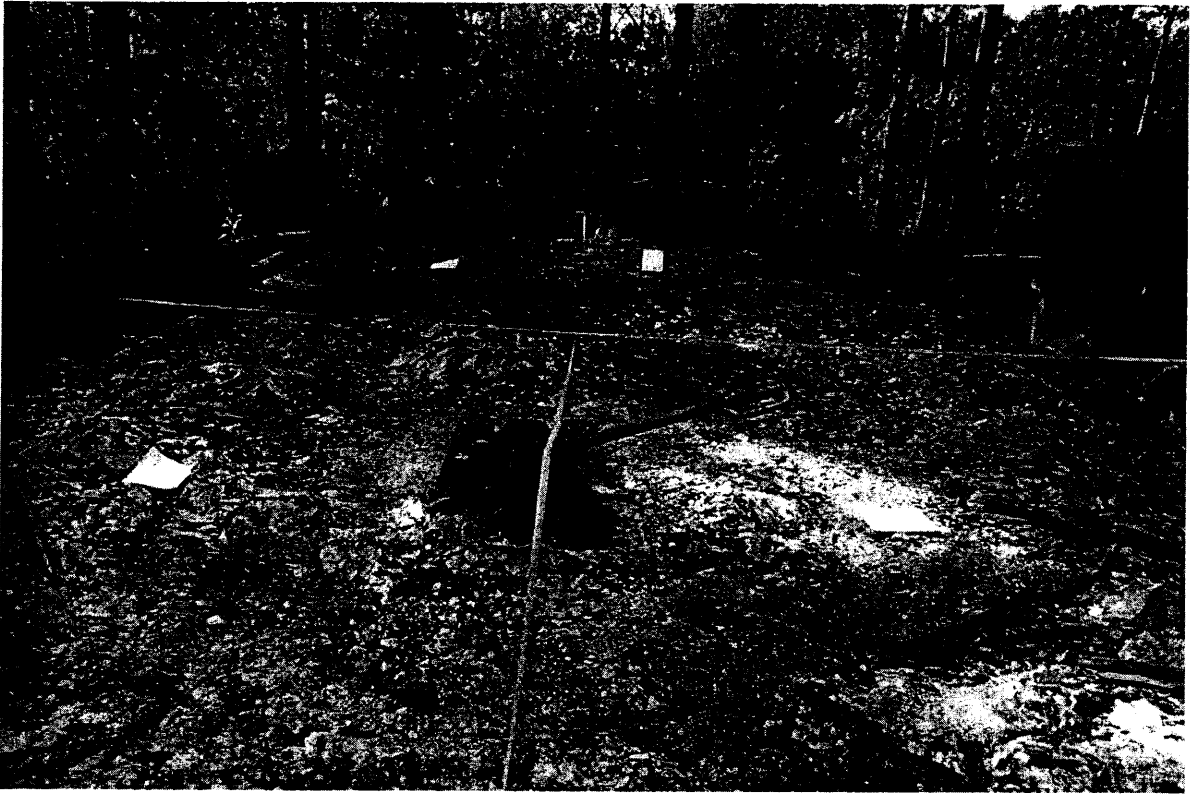
Figure 3 – Subject structure cordoned off into quadrants prior to sifting.

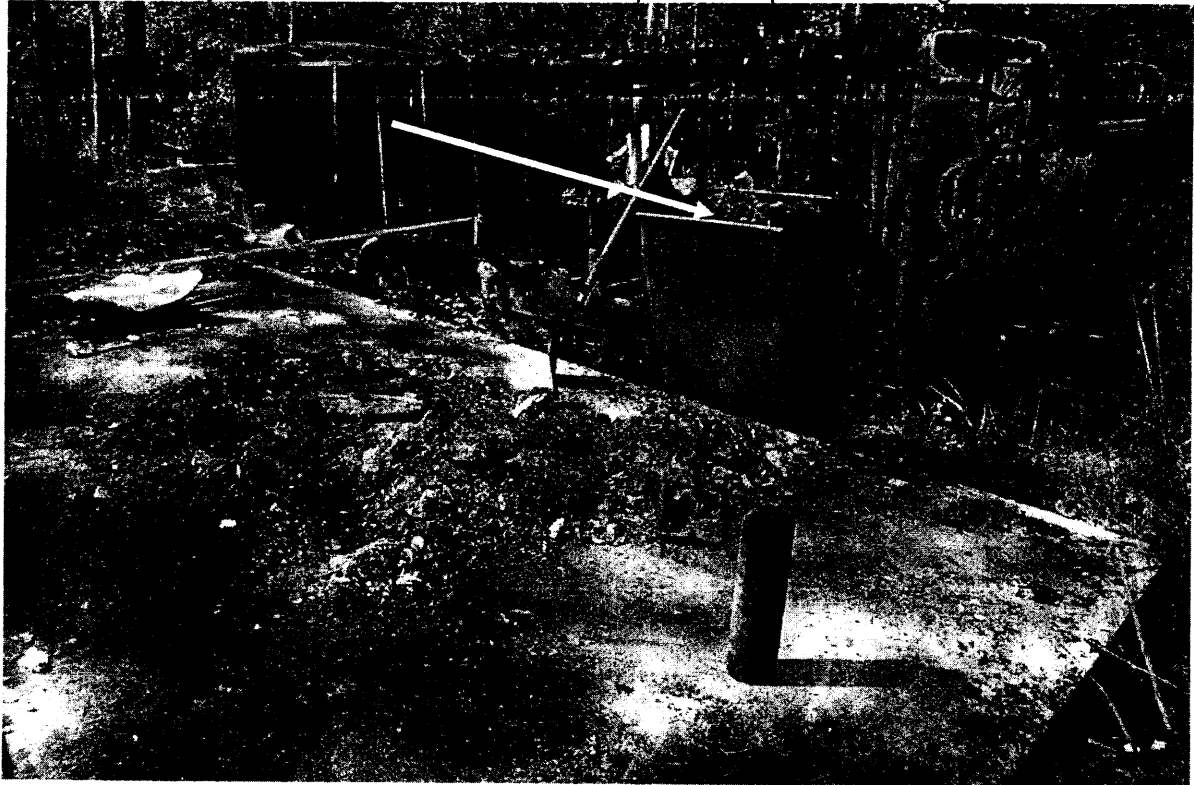
Figure 4 – Sifting process in operation. The sifter is indicated by the arrow.

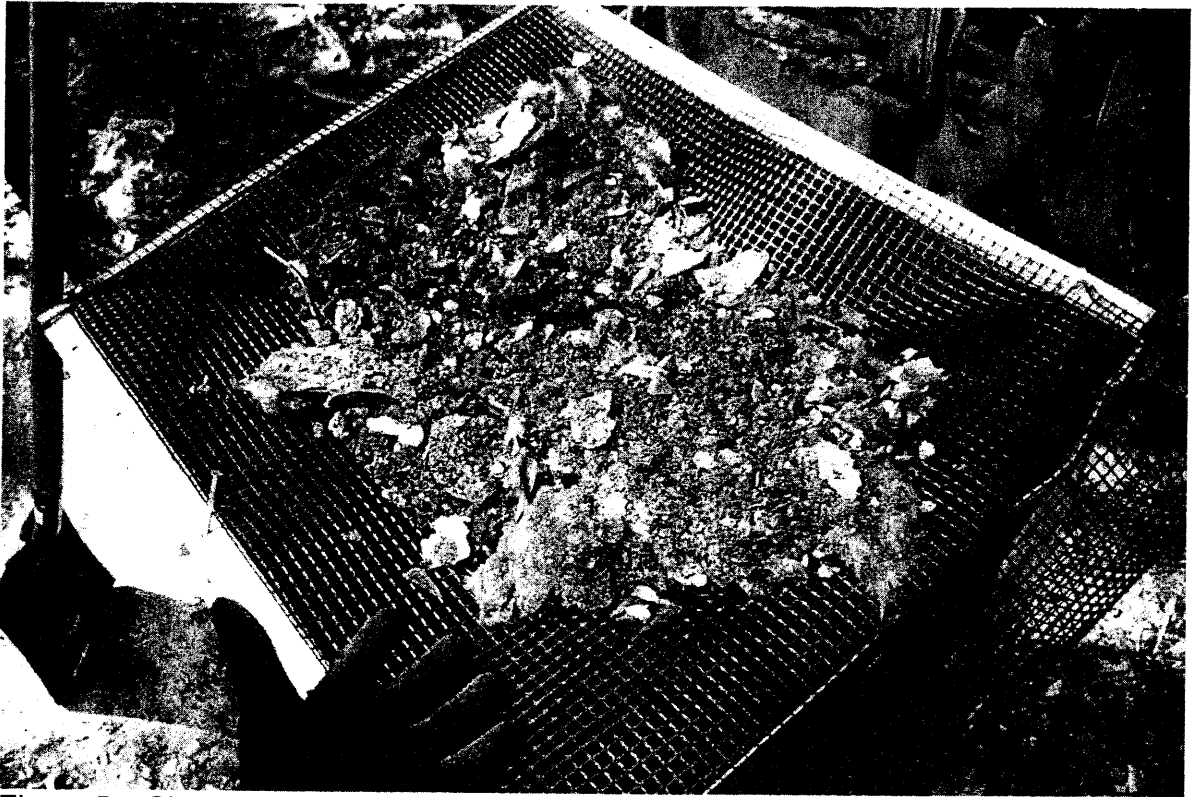
Figure 5 – Close-up view of the sifter showing the 1/4 inch hardware cloth

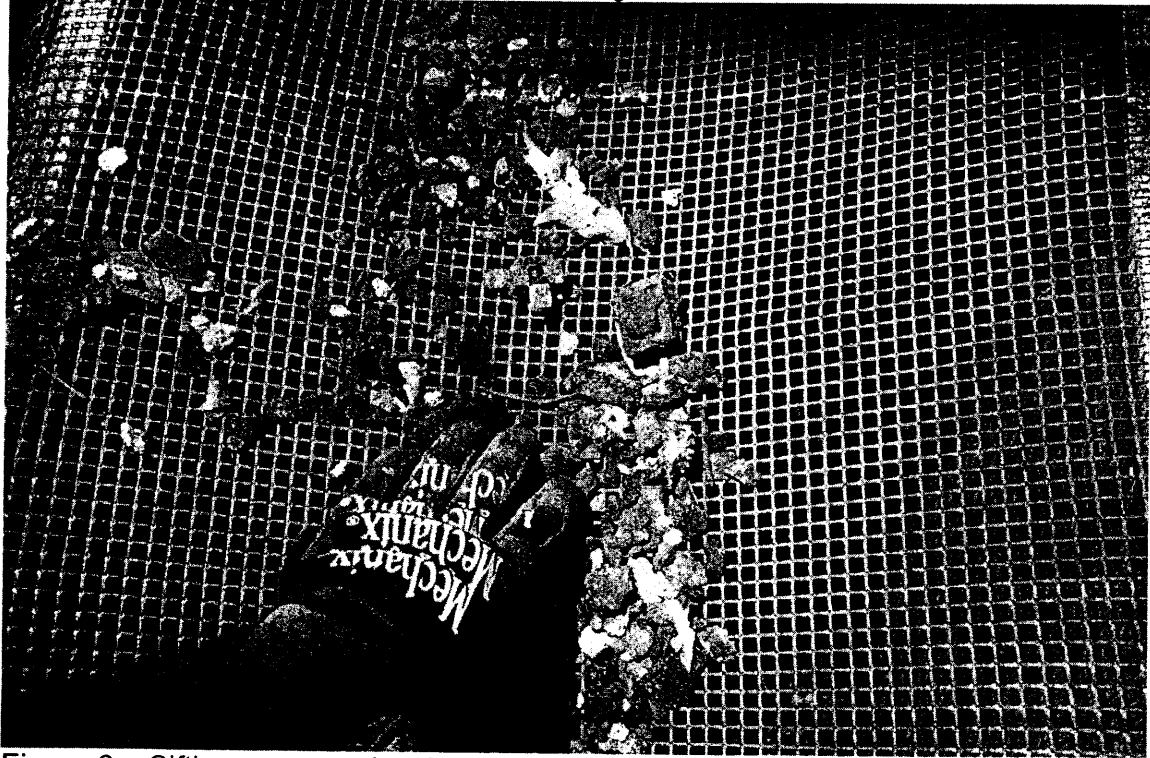
Figure 6 – Sifting process showing the items which can be retained during the process.

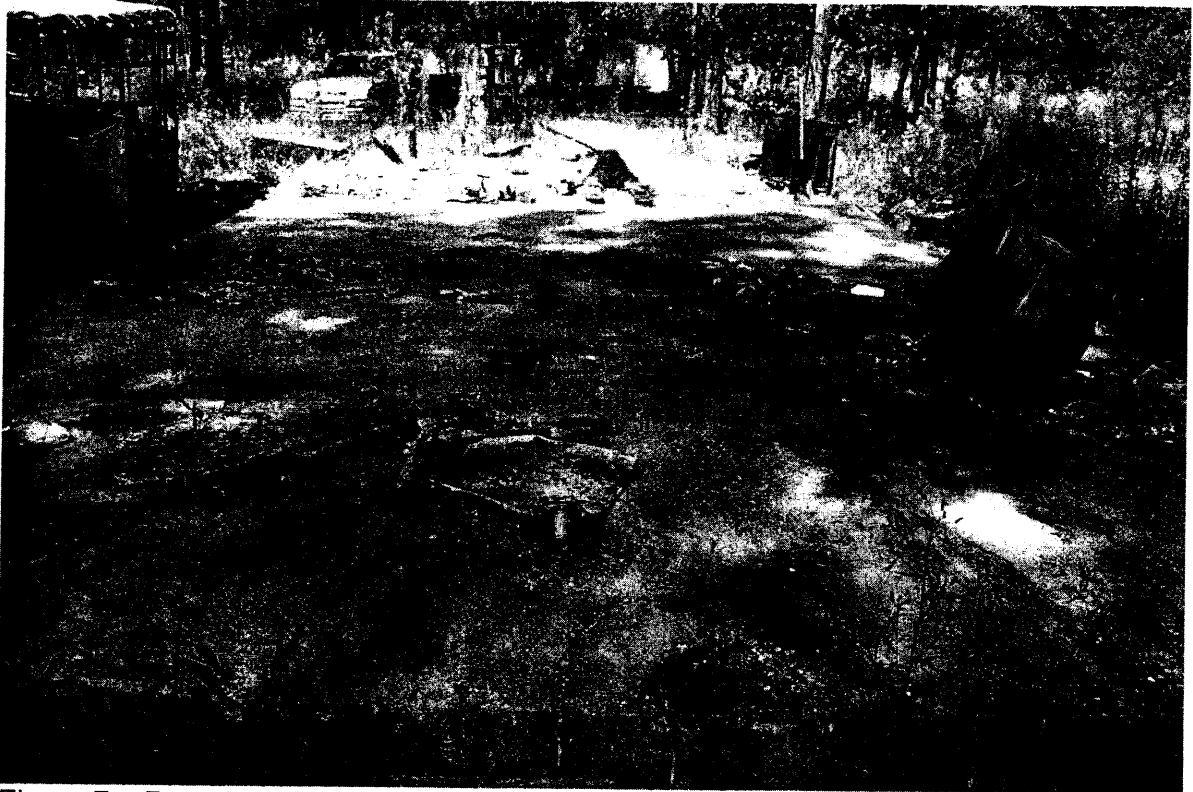
Figure 7 – Remains of larger items after the sifting process was complete.

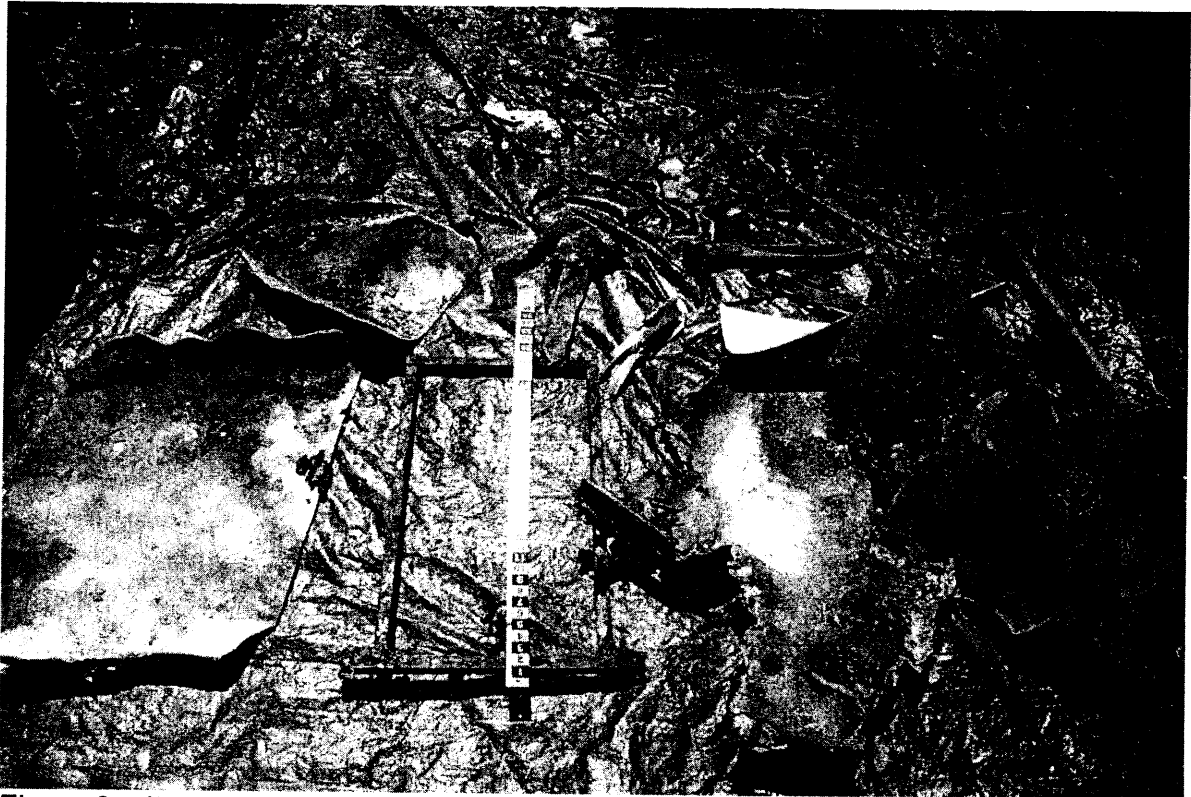
within the confines of the computer. Section B consisted of a heavy duty pallet jack, metal desk and pallet wrapper. Other than an electrical outlet and other electrical conductors leading to this area no other contents were discovered in Section B. Section C is the northwest area of the structure where the surviving "wash tank" was located. Just outside of Section C was the air compressor. Items shown on the blue tarp as figure 9 indicate the findings within the section of Section C. Numerous piping supplies and electrical conductors leading to the wash tank area were also noted within this area. Straddling sections C & D on the north side of the structure was the remains of another metal basin. In addition to this metal bin the remains of some rollers were also discovered in Section D. A small polystyrene cooler was also located in this area as well as some springs, light fixtures and ballasts for light fixtures.

Figure 9 – Items recovered from the back right quadrant (area C).

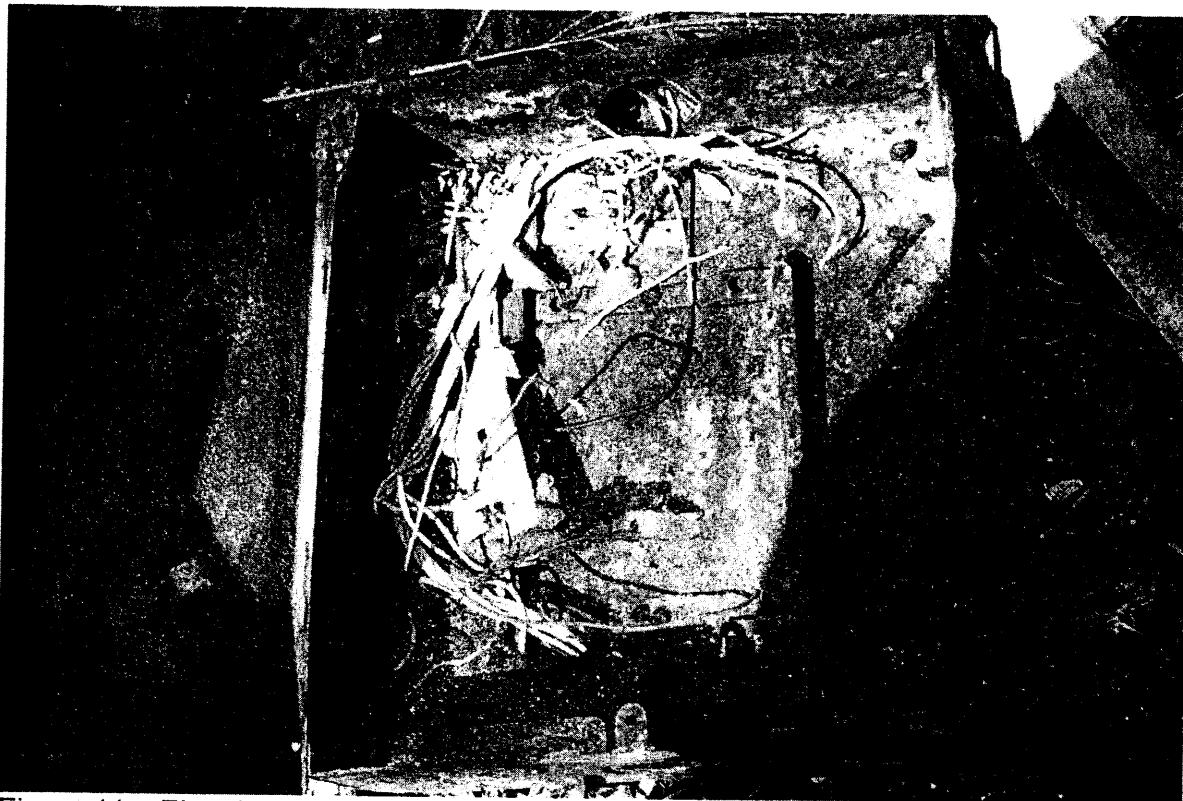
The remainder of fluorescent light fixtures and an electrical disconnect box were also discovered during the sifting process. These items are shown in figures 11 & 12. The electrical box is a disconnect box and not a control box as would be associated with automatic equipment. The remains of a large file cabinet should also be noted to have been found on the southeast exterior of the structure. Examination of the exterior doors and other items of that nature was also conducted and they were discovered to be in place at the time of the fire. Some of the items that were previously identified in Mr. Parrot's deposition as rails possibly to the semiautomatic or automatic equipment were actually pieces of roof flashing as shown in figure 13.

Figure 11 – Electrical panel.
